I-270 NORTH CORRIDOR STUDY EXISTING CONDITIONS - BRIDGE AND PAVEMENT

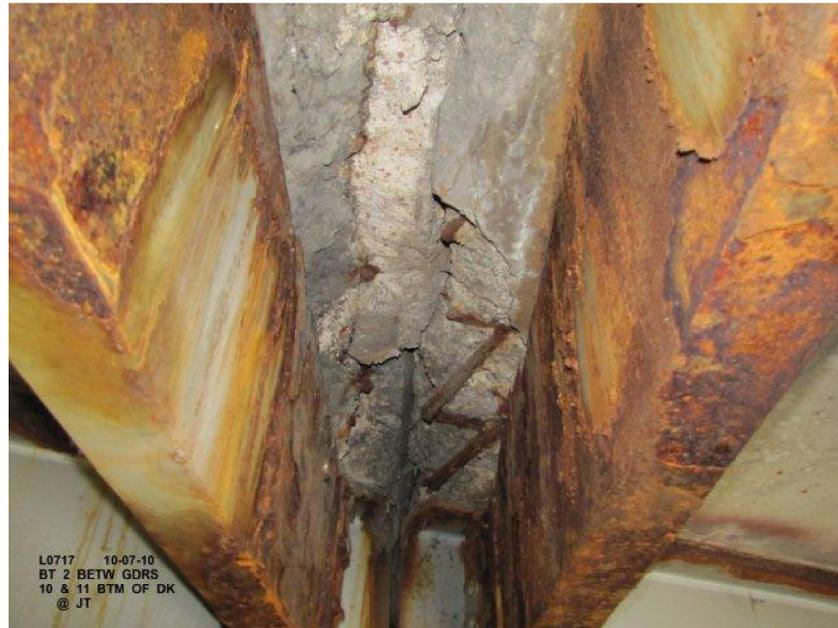
L0717 10-07-10
BT 2 BETW GDRS
10 & 11 BTM OF DK
@ JT

**I-270 BRIDGE OVER COLDWATER CREEK-
EXPOSED REBAR AND PACK-RUST ON GIRDER**

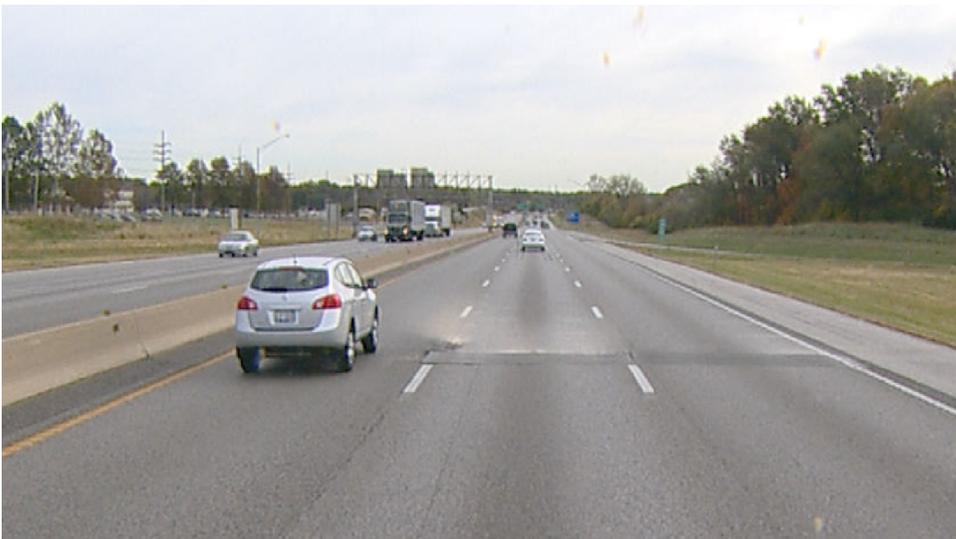
**EASTBOUND I-270 EAST OF MO 367 -
DETERIORATING UNDERLAYING CONCRETE**

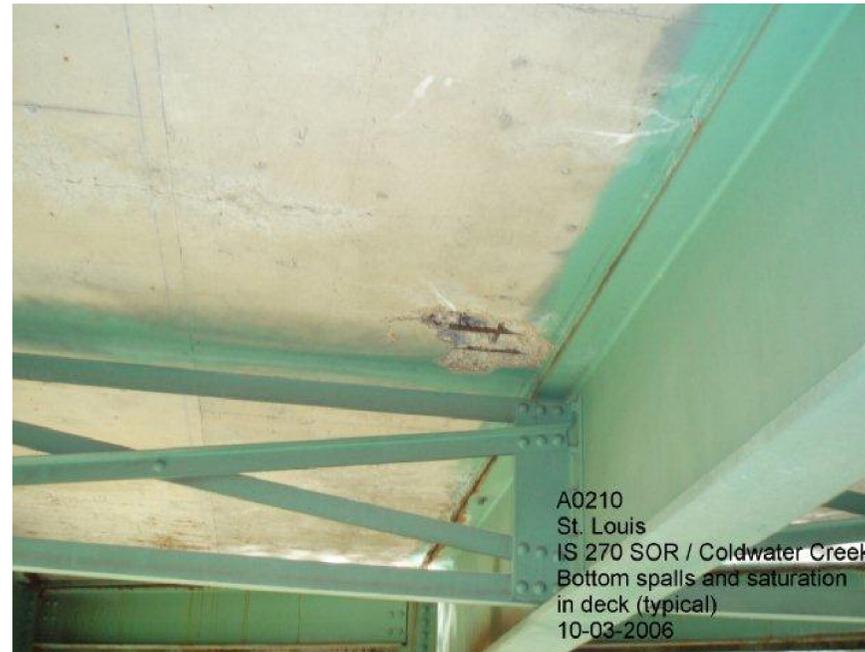
A0210
St. Louis
IS 270 SOR / Coldwater Creek
Bottom spalls and saturation
in deck (typical)
10-03-2006

**PERSHALL RD BRIDGE OVER COLDWATER CREEK
EXPOSED REBAR ON BOTTOM OF DECK**

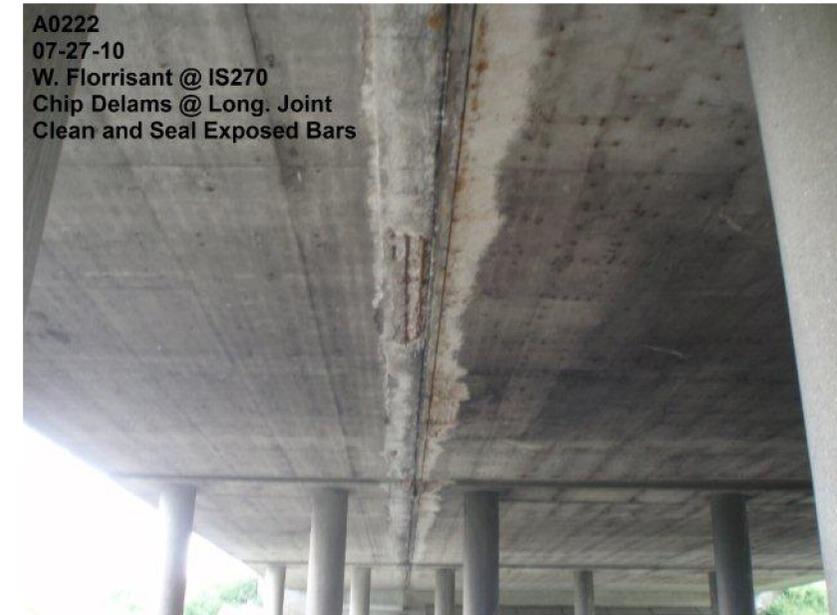
A0222
07-27-10
W. Florissant @ IS270
Chip Delams @ Long. Joint
Clean and Seal Exposed Bars

**WEST FLORISSANT AT I-270 -
EXPOSED REBAR ON JOINT**

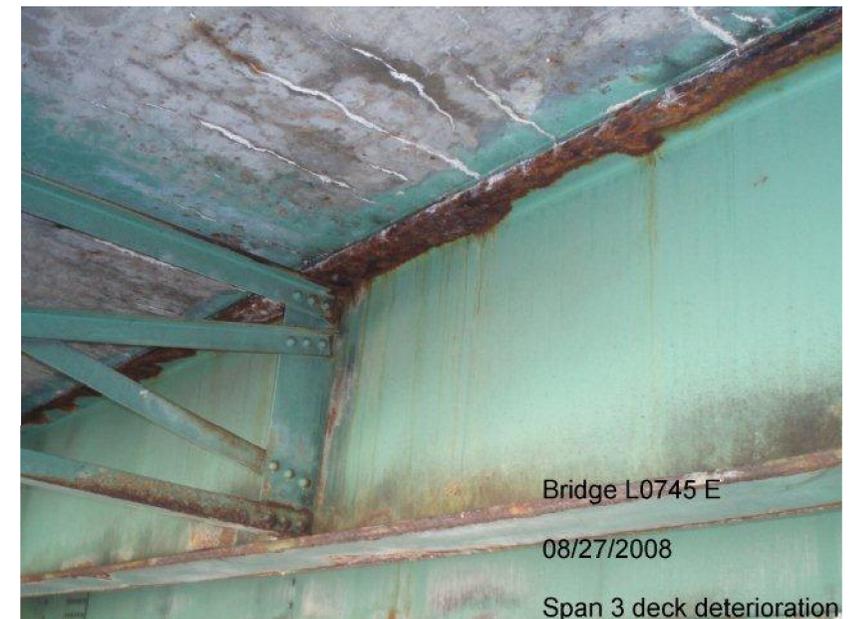
Bridge L0745 E
08/27/2008
Span 3 deck deterioration

**EASTBOUND I-270 BRIDGE OVER RTE N-
DECK CRACKING AND PACK-RUST ON GIRDER**
