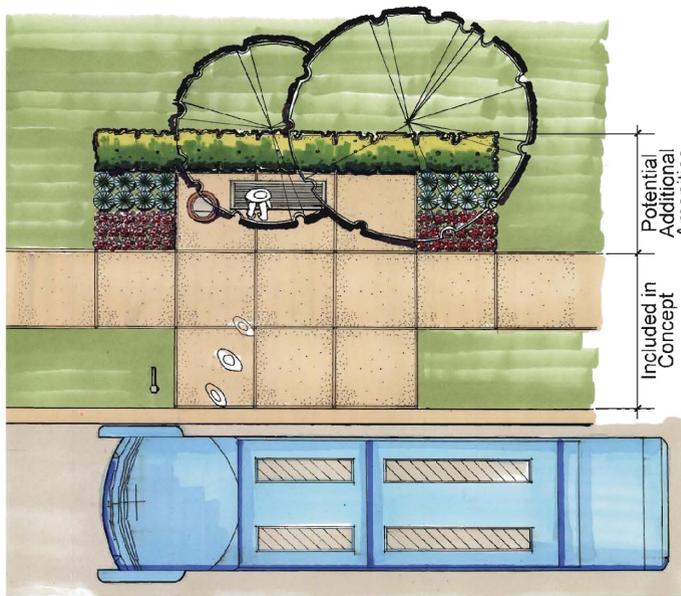
Potential Transit Stop (plan view)

Potential Transit Stops
 With an ATA bus route along the corridor, there are several stops, yet many are without sidewalk access. At a minimum, transit stops will include an accessible route to the stop, signage, and paved access to curb edge. Amenities may be provided and could include benches, trash receptacles and landscaping, as shown above.

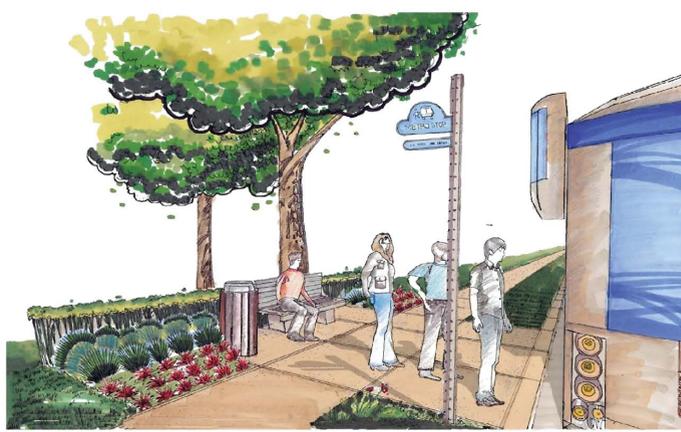
Potential Transit Stop (perspective view)

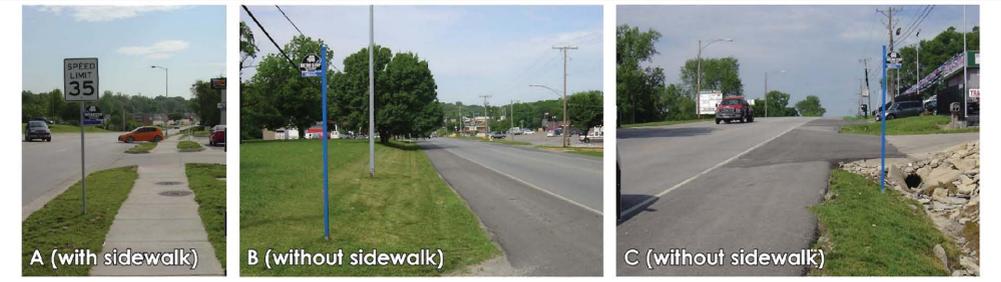
Existing Transit Conditions (see plan)

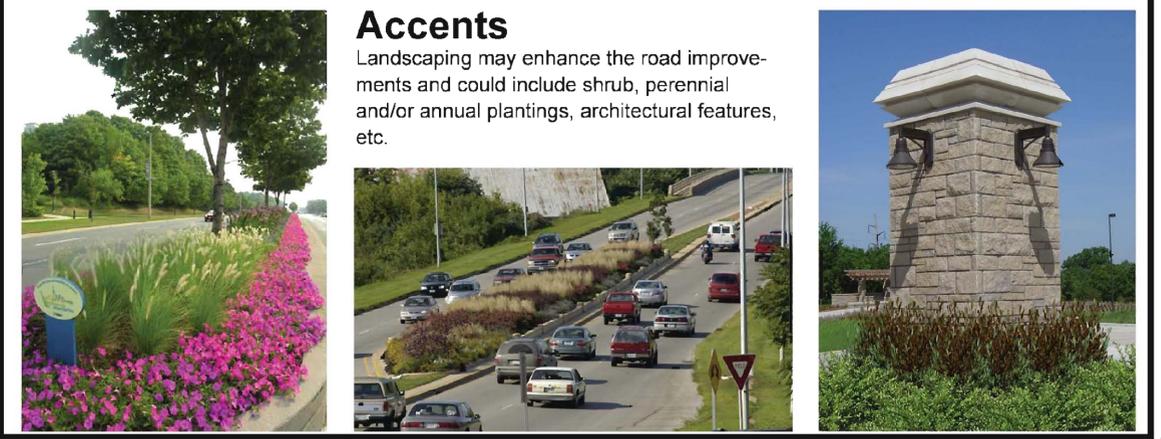
Accents
 Landscaping may enhance the road improvements and could include shrub, perennial and/or annual plantings, architectural features, etc.

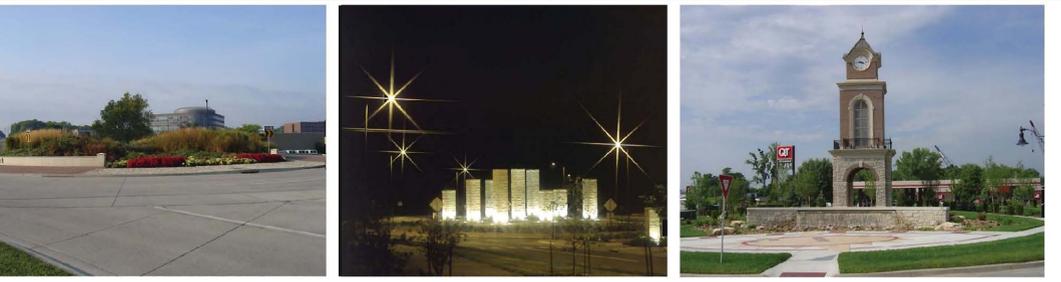
Roundabouts
 At a minimum, roundabouts would include turf and/or groundcovers. Other enhancements may include trees, shrubs and accent plantings, low walls, earthen mounding, art, and/or monumentation.

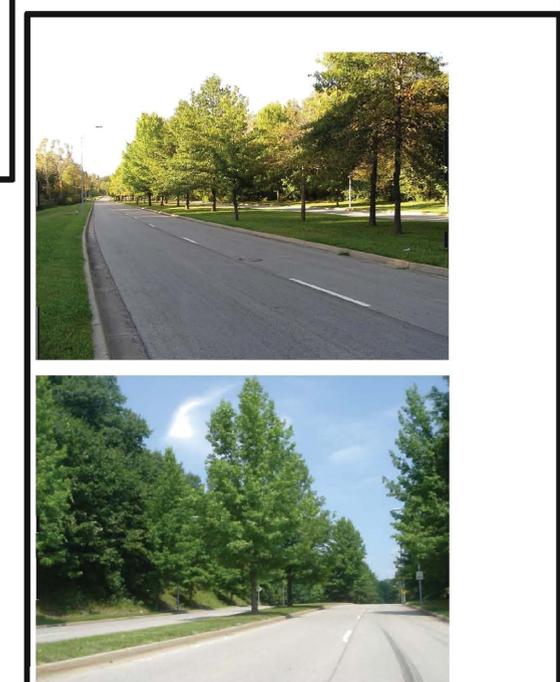
Street Trees
 Proposed improvements include, at a minimum, shade trees, ornamental trees and groundcovers.

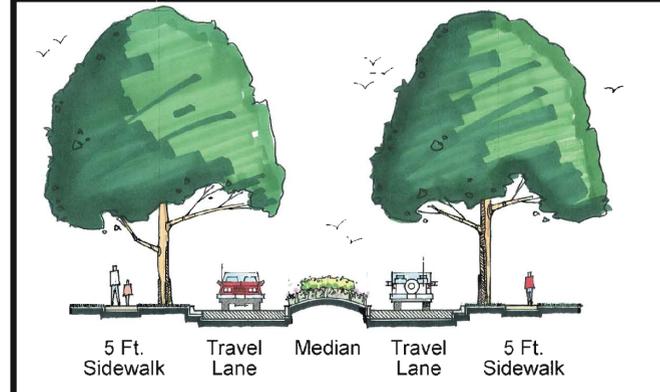
Typical Street Section at Median

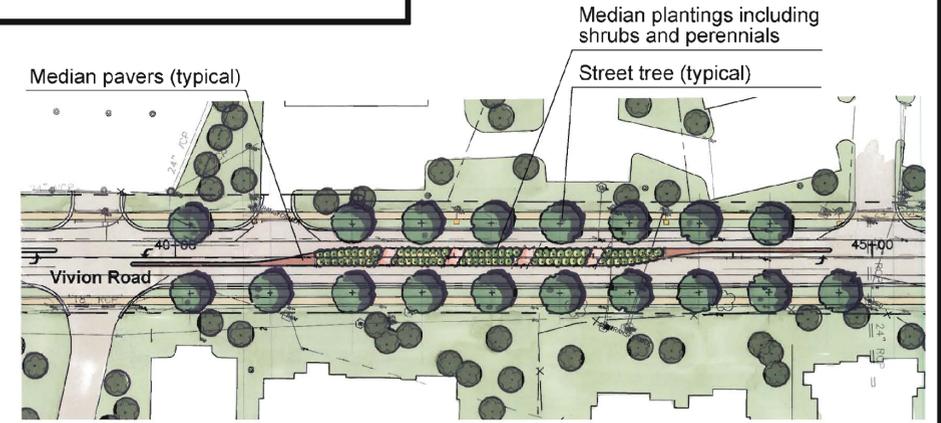
Typical Street Plan at Median
